# Manhole Inspection Summary

Manhole # S41A\_\_041MH

Insp Date: **6/26/08 8:45 AM**

**Location** Address: **500 n caroline st**

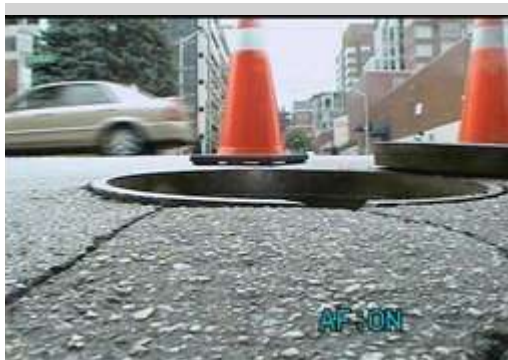
Location View

Condition: ☐ Sound ☒ **Cracked** ☐ Leaks

has a piece missing in frame

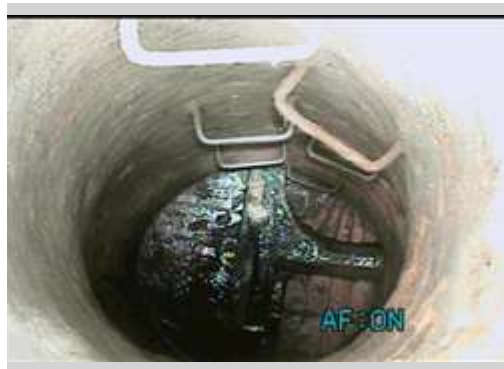
Top View

top view & steps

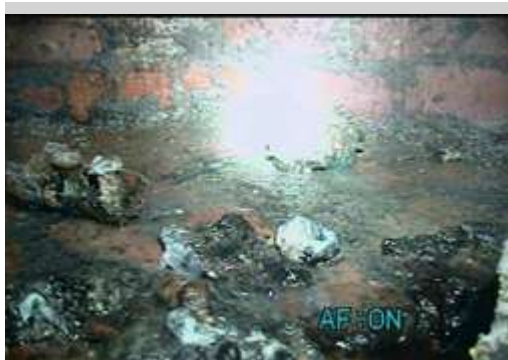
misc

bench debris

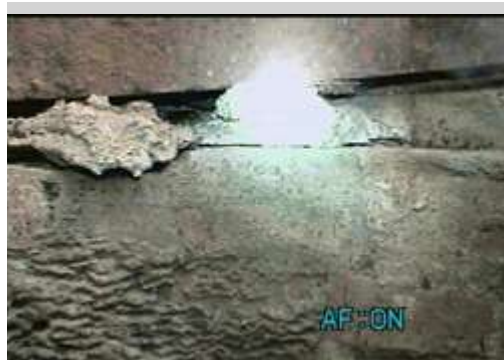
Defect 1

Condition: ☐ Sound ☒ **Cracked** ☐ Root Intrusion ☐ Loose Brick ☐ Deteriorated

Chimney cracked, frame adj

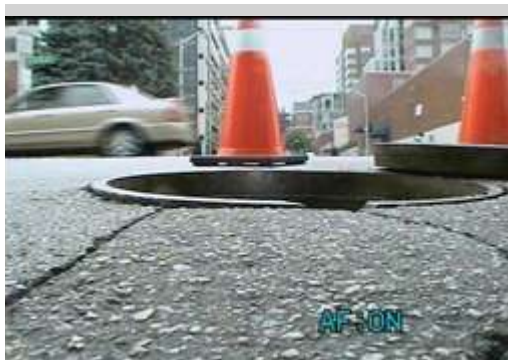
Defect 4

frame cracked

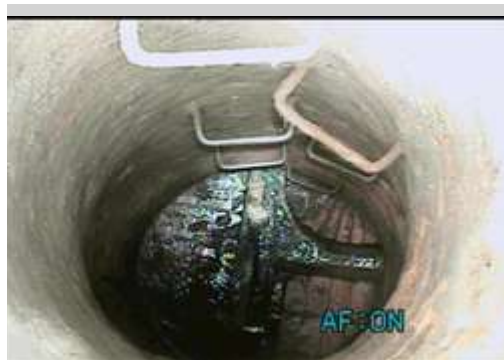
Defect 5

Count: **6** Missing: **0** ☒ **Corroded**

steps

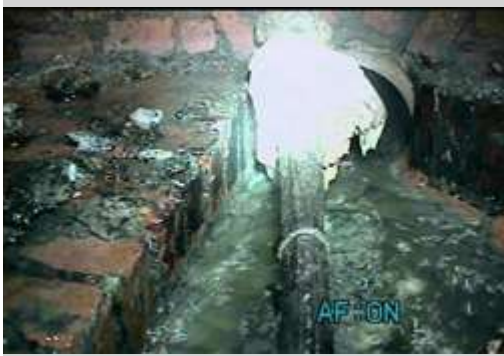
Defect 3

Condition: ☐ Sound ☐ Cracked ☐ Root Intrusion ☐ Deteriorated ☐ Leaks ☒ **Debris**

channel debris

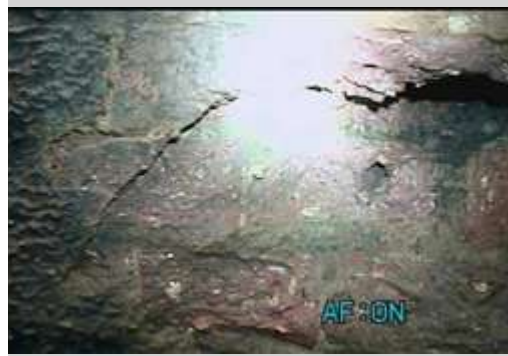
Defect 2

Condition: ☐ Sound ☒ **Cracked** ☐ Root Intrusion ☒ **Loose Brick** ☒ **Deteriorated**

hole in corbel, corbel condition loose bricks, cracked, deteriorated,
